**Report: Chilt/RF12101**

**A fire resistance test performed two  
single leaf single acting doorsets**

**Test conducted in accordance with  
BS 476: Parts 20/22: 1987**

**Test date: 19th October 2012**

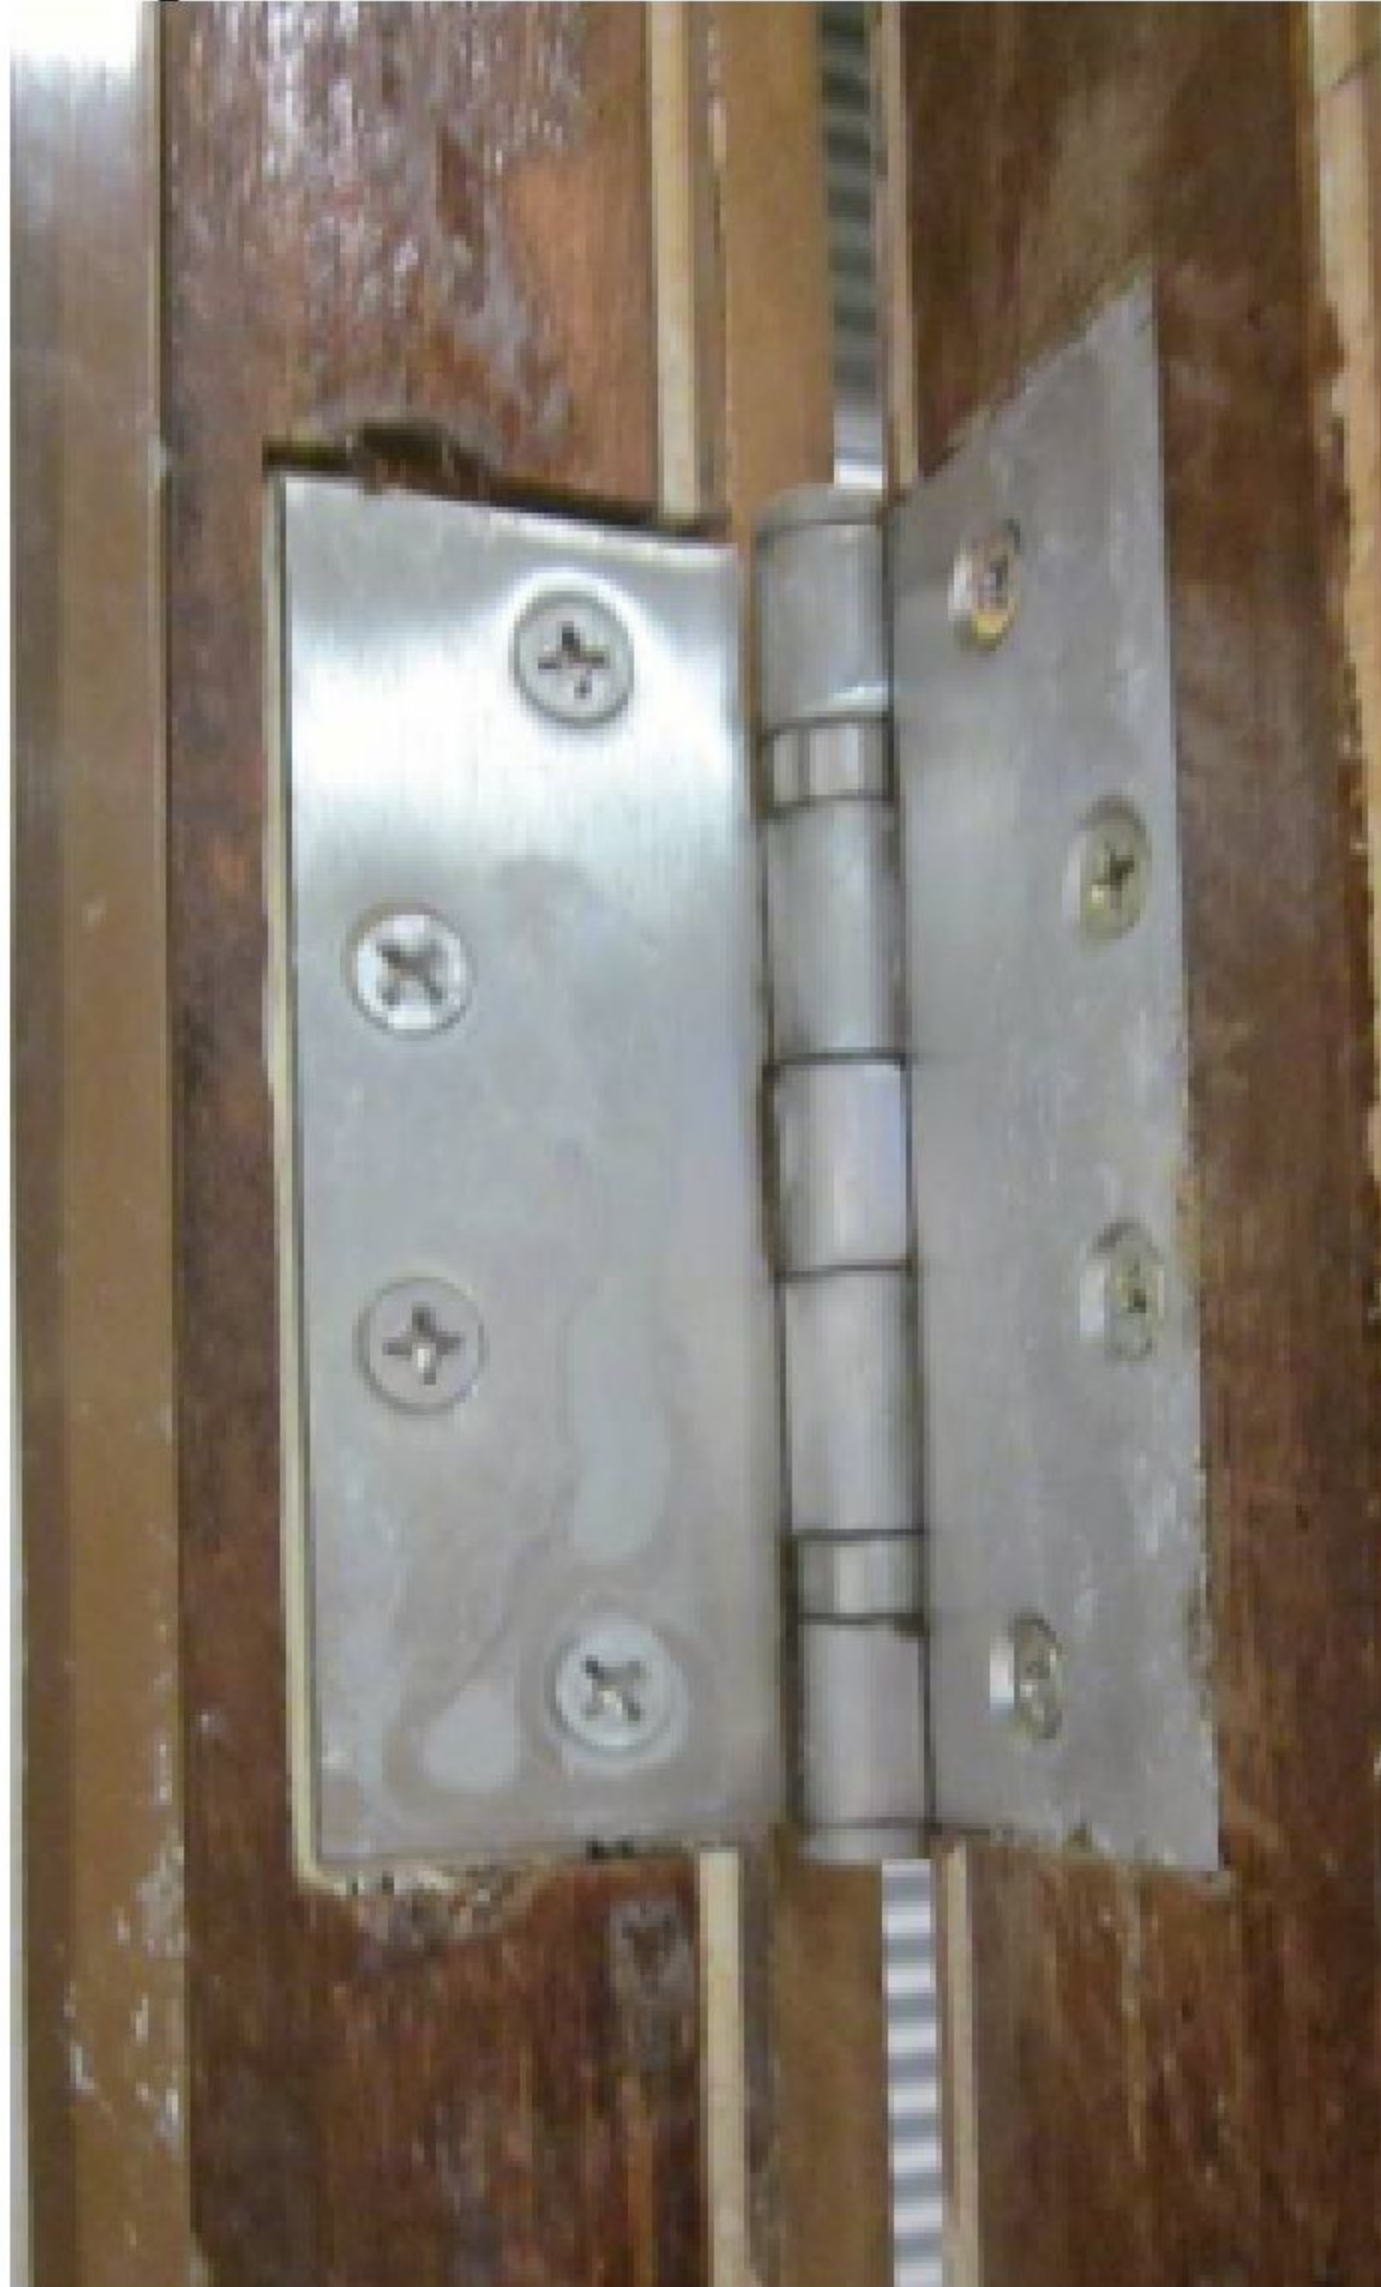
Hinges – both doorsets

Make/type	Size (mm)	Location
Around hinges	Continuous	-	Seal in frame reveal remains continuous past hinge blade in frame reveal
Under hinge blade	None fitted	-	-
Encasing latch body	None fitted	-	-
Under latch forend	None fitted	-	-
Around latch keep	Continuous	-	Seal in frame reveal remains continuous past latch keep in frame reveal
Under latch keep	None fitted	-	-

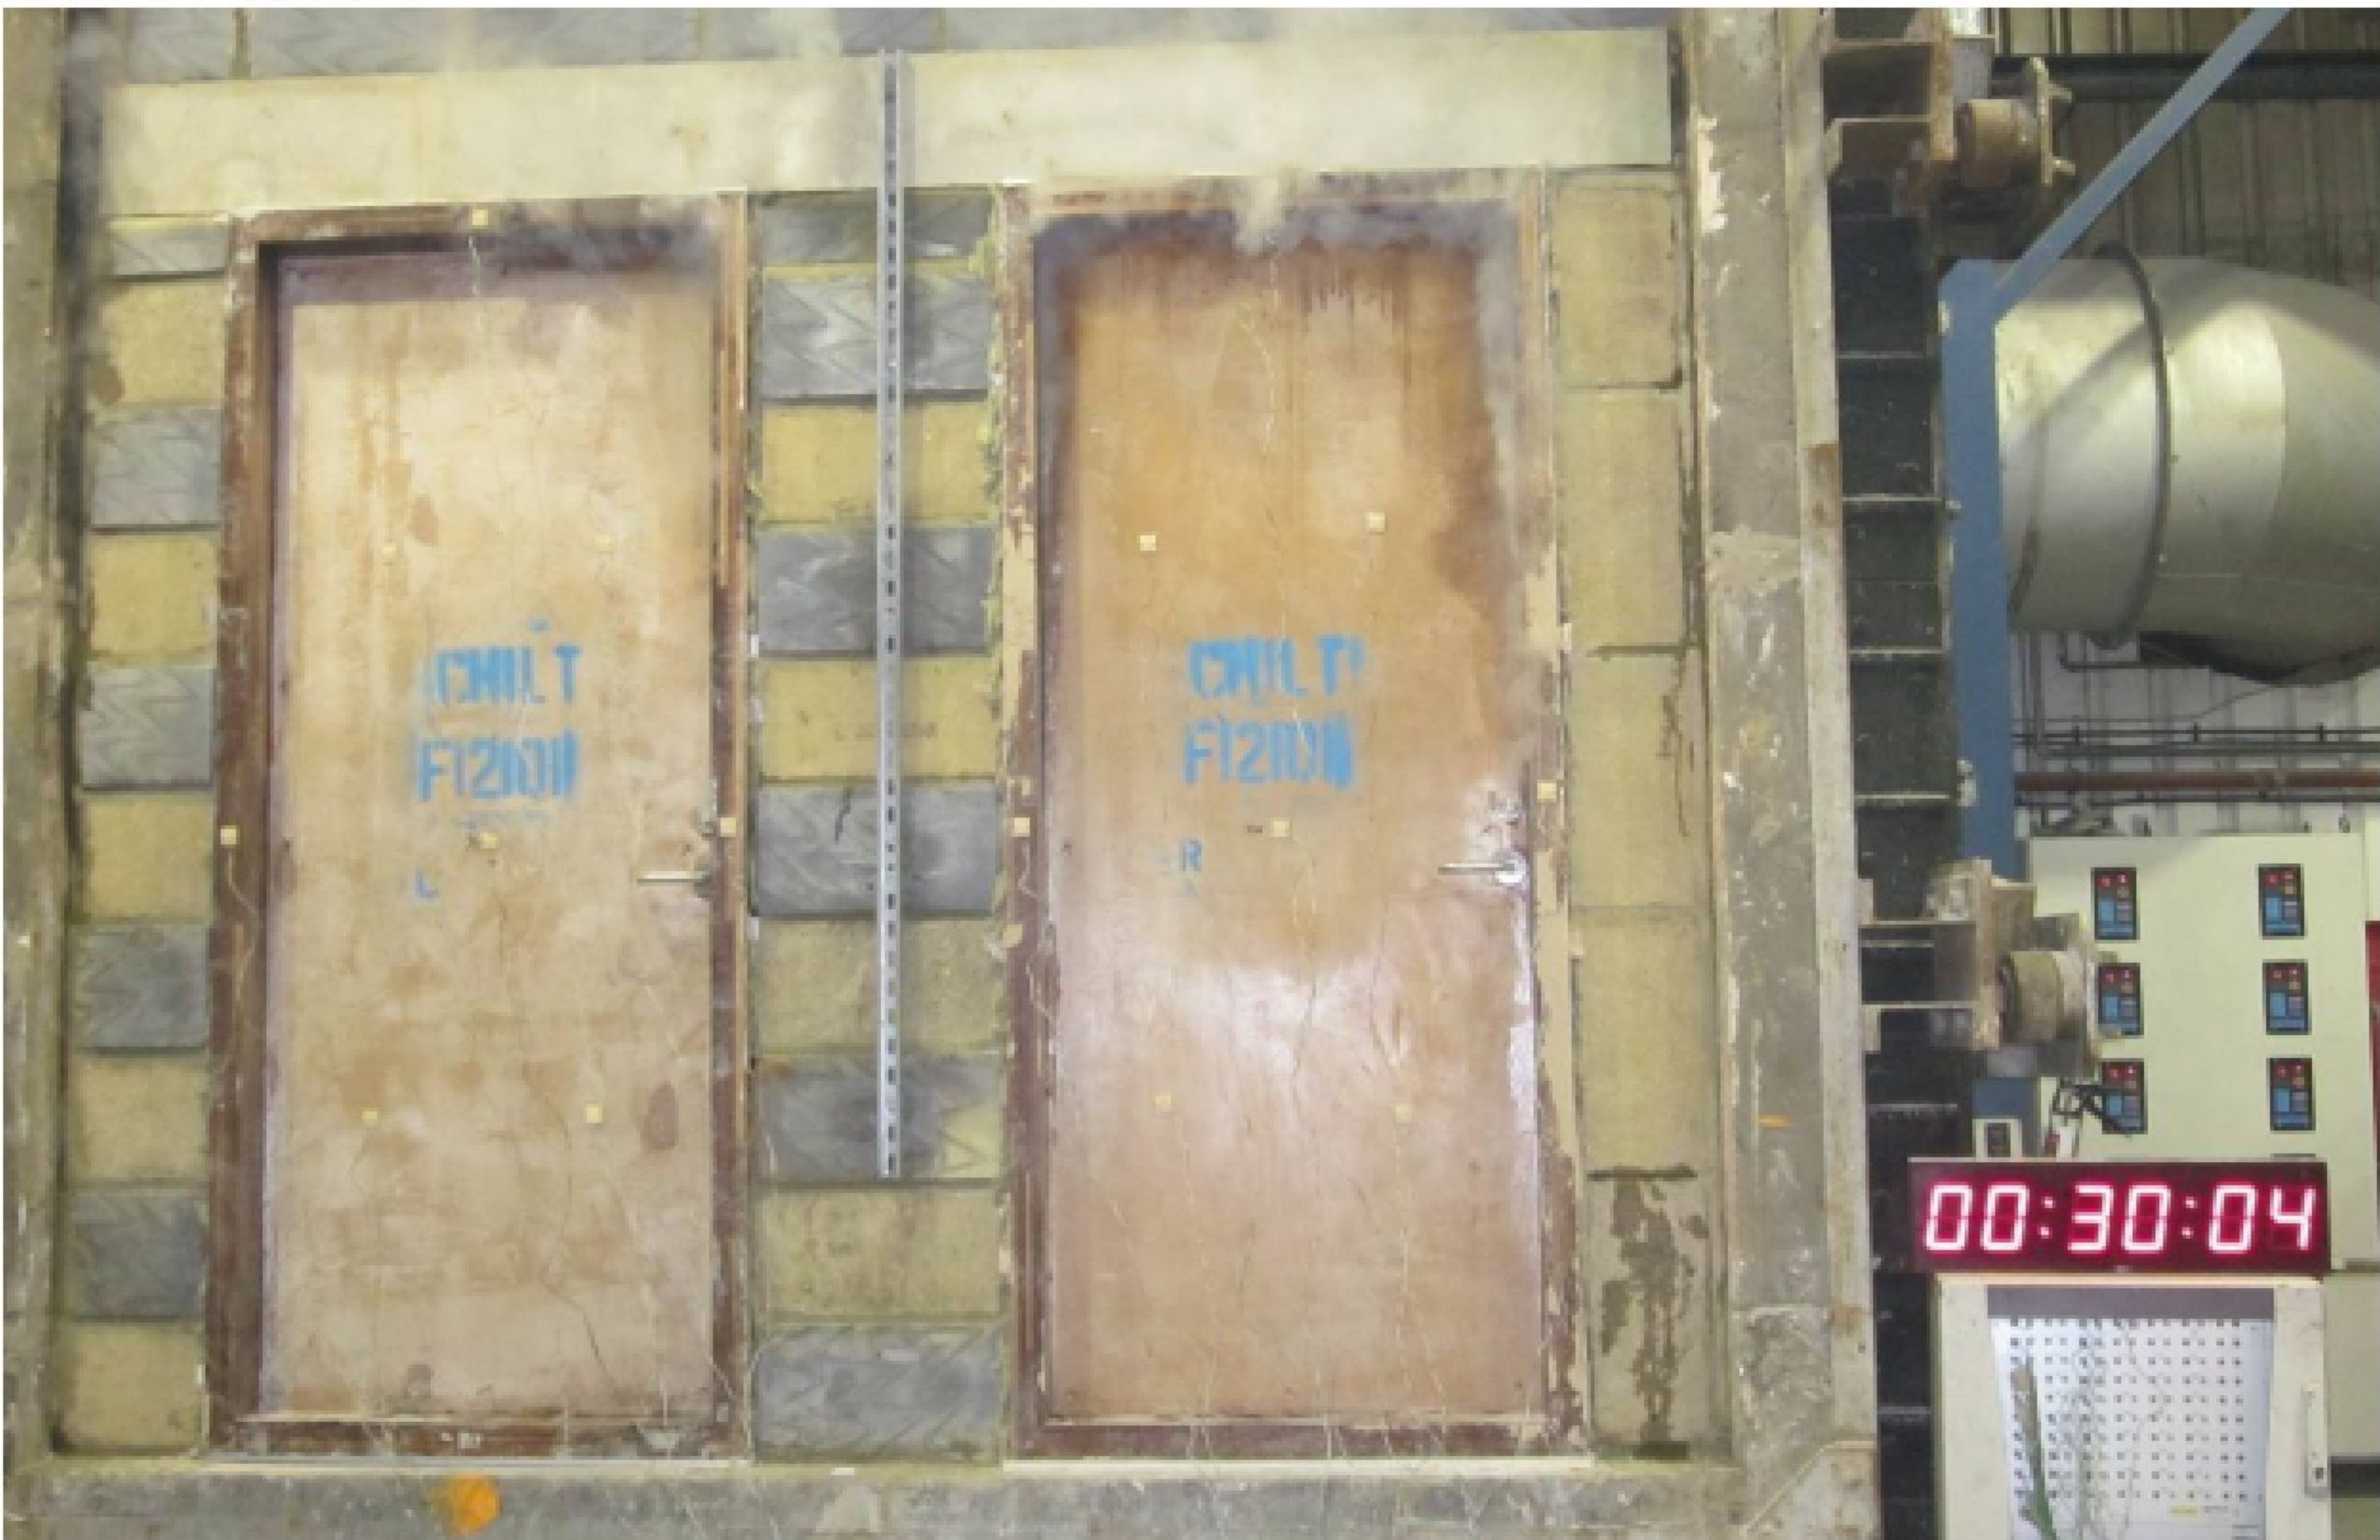
After 30 minutes

24.14	Exposed face of both leaves, the faces are peeling and flaking.
29.35	Doorset B, there is an increase in the level of smoke issuing from the closing edge of the leaf.

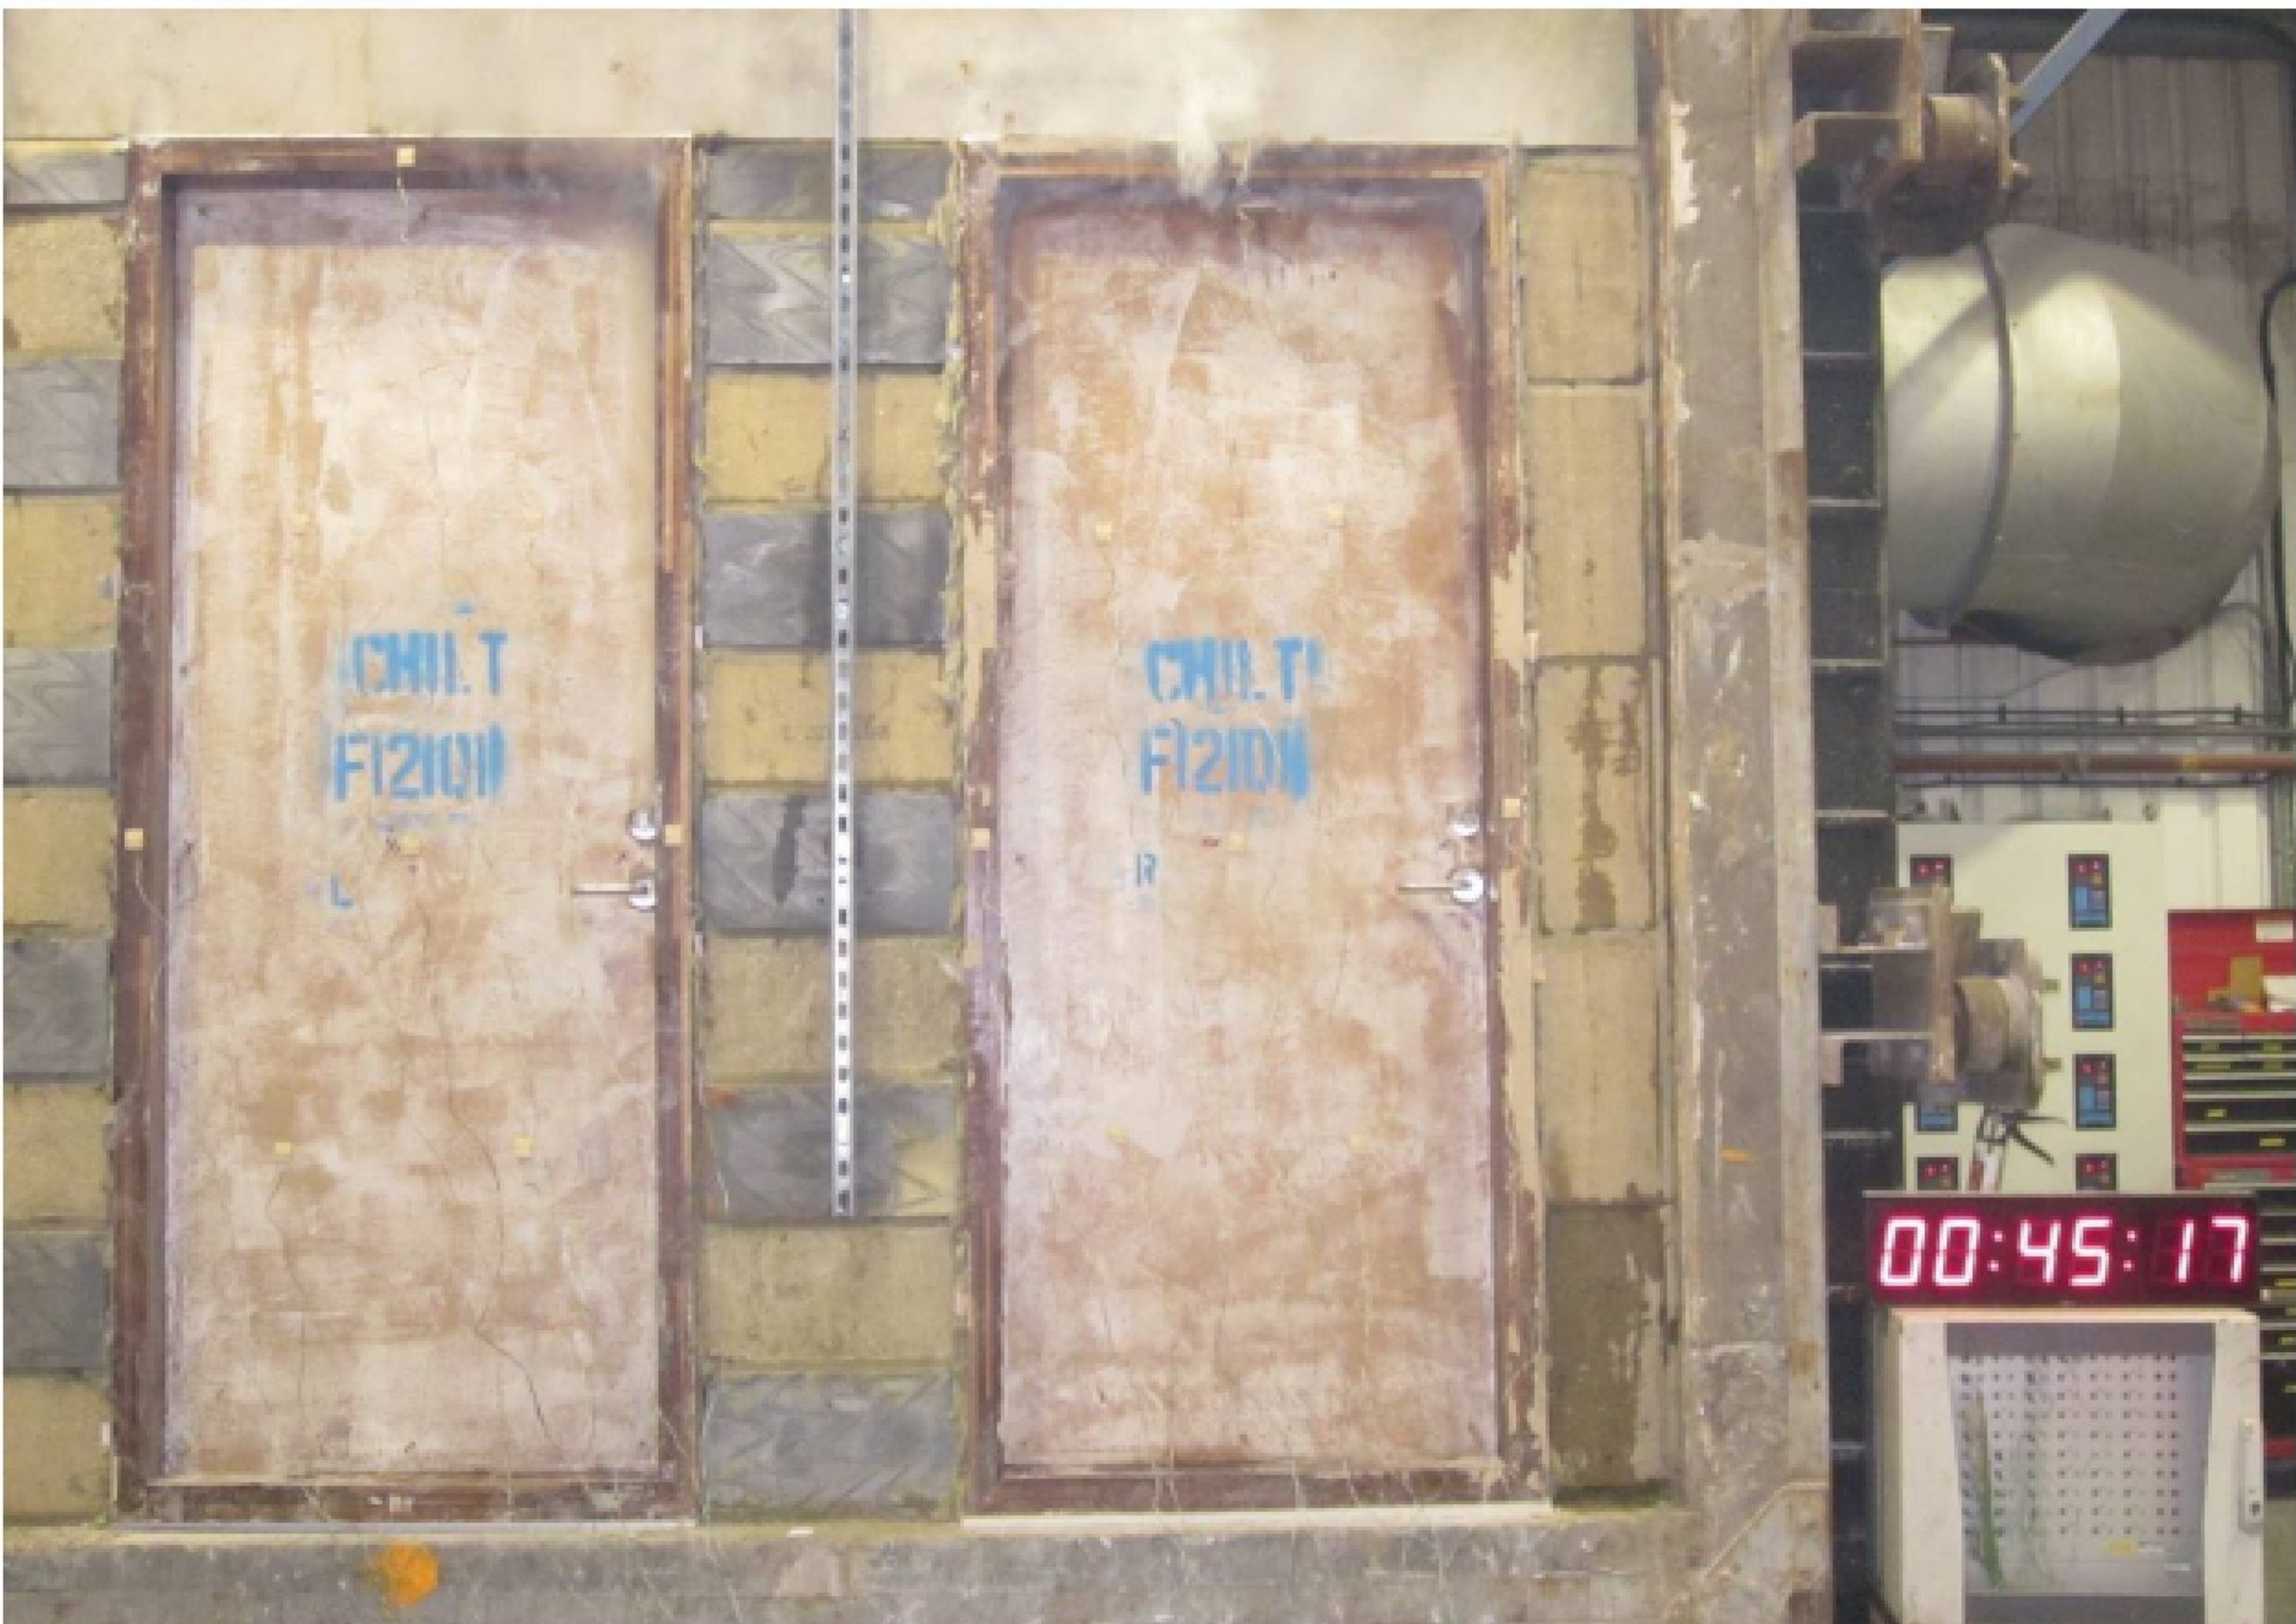
After 45 minutes

- 40.14 Exposed face of doorset B, the facing of the leaf is beginning to break up and the top half has fallen away
- 41.43 Doorset B, there is smoke issuing from the top hinge position, the head and the top closing corner of the leaf.

- 42.36 Exposed face doorset A, the facing is starting to crack.
- 45.08 Doorset B, there is discolouration at the head of the leaf.  
Doorset A, there is discolouration at the lock position.

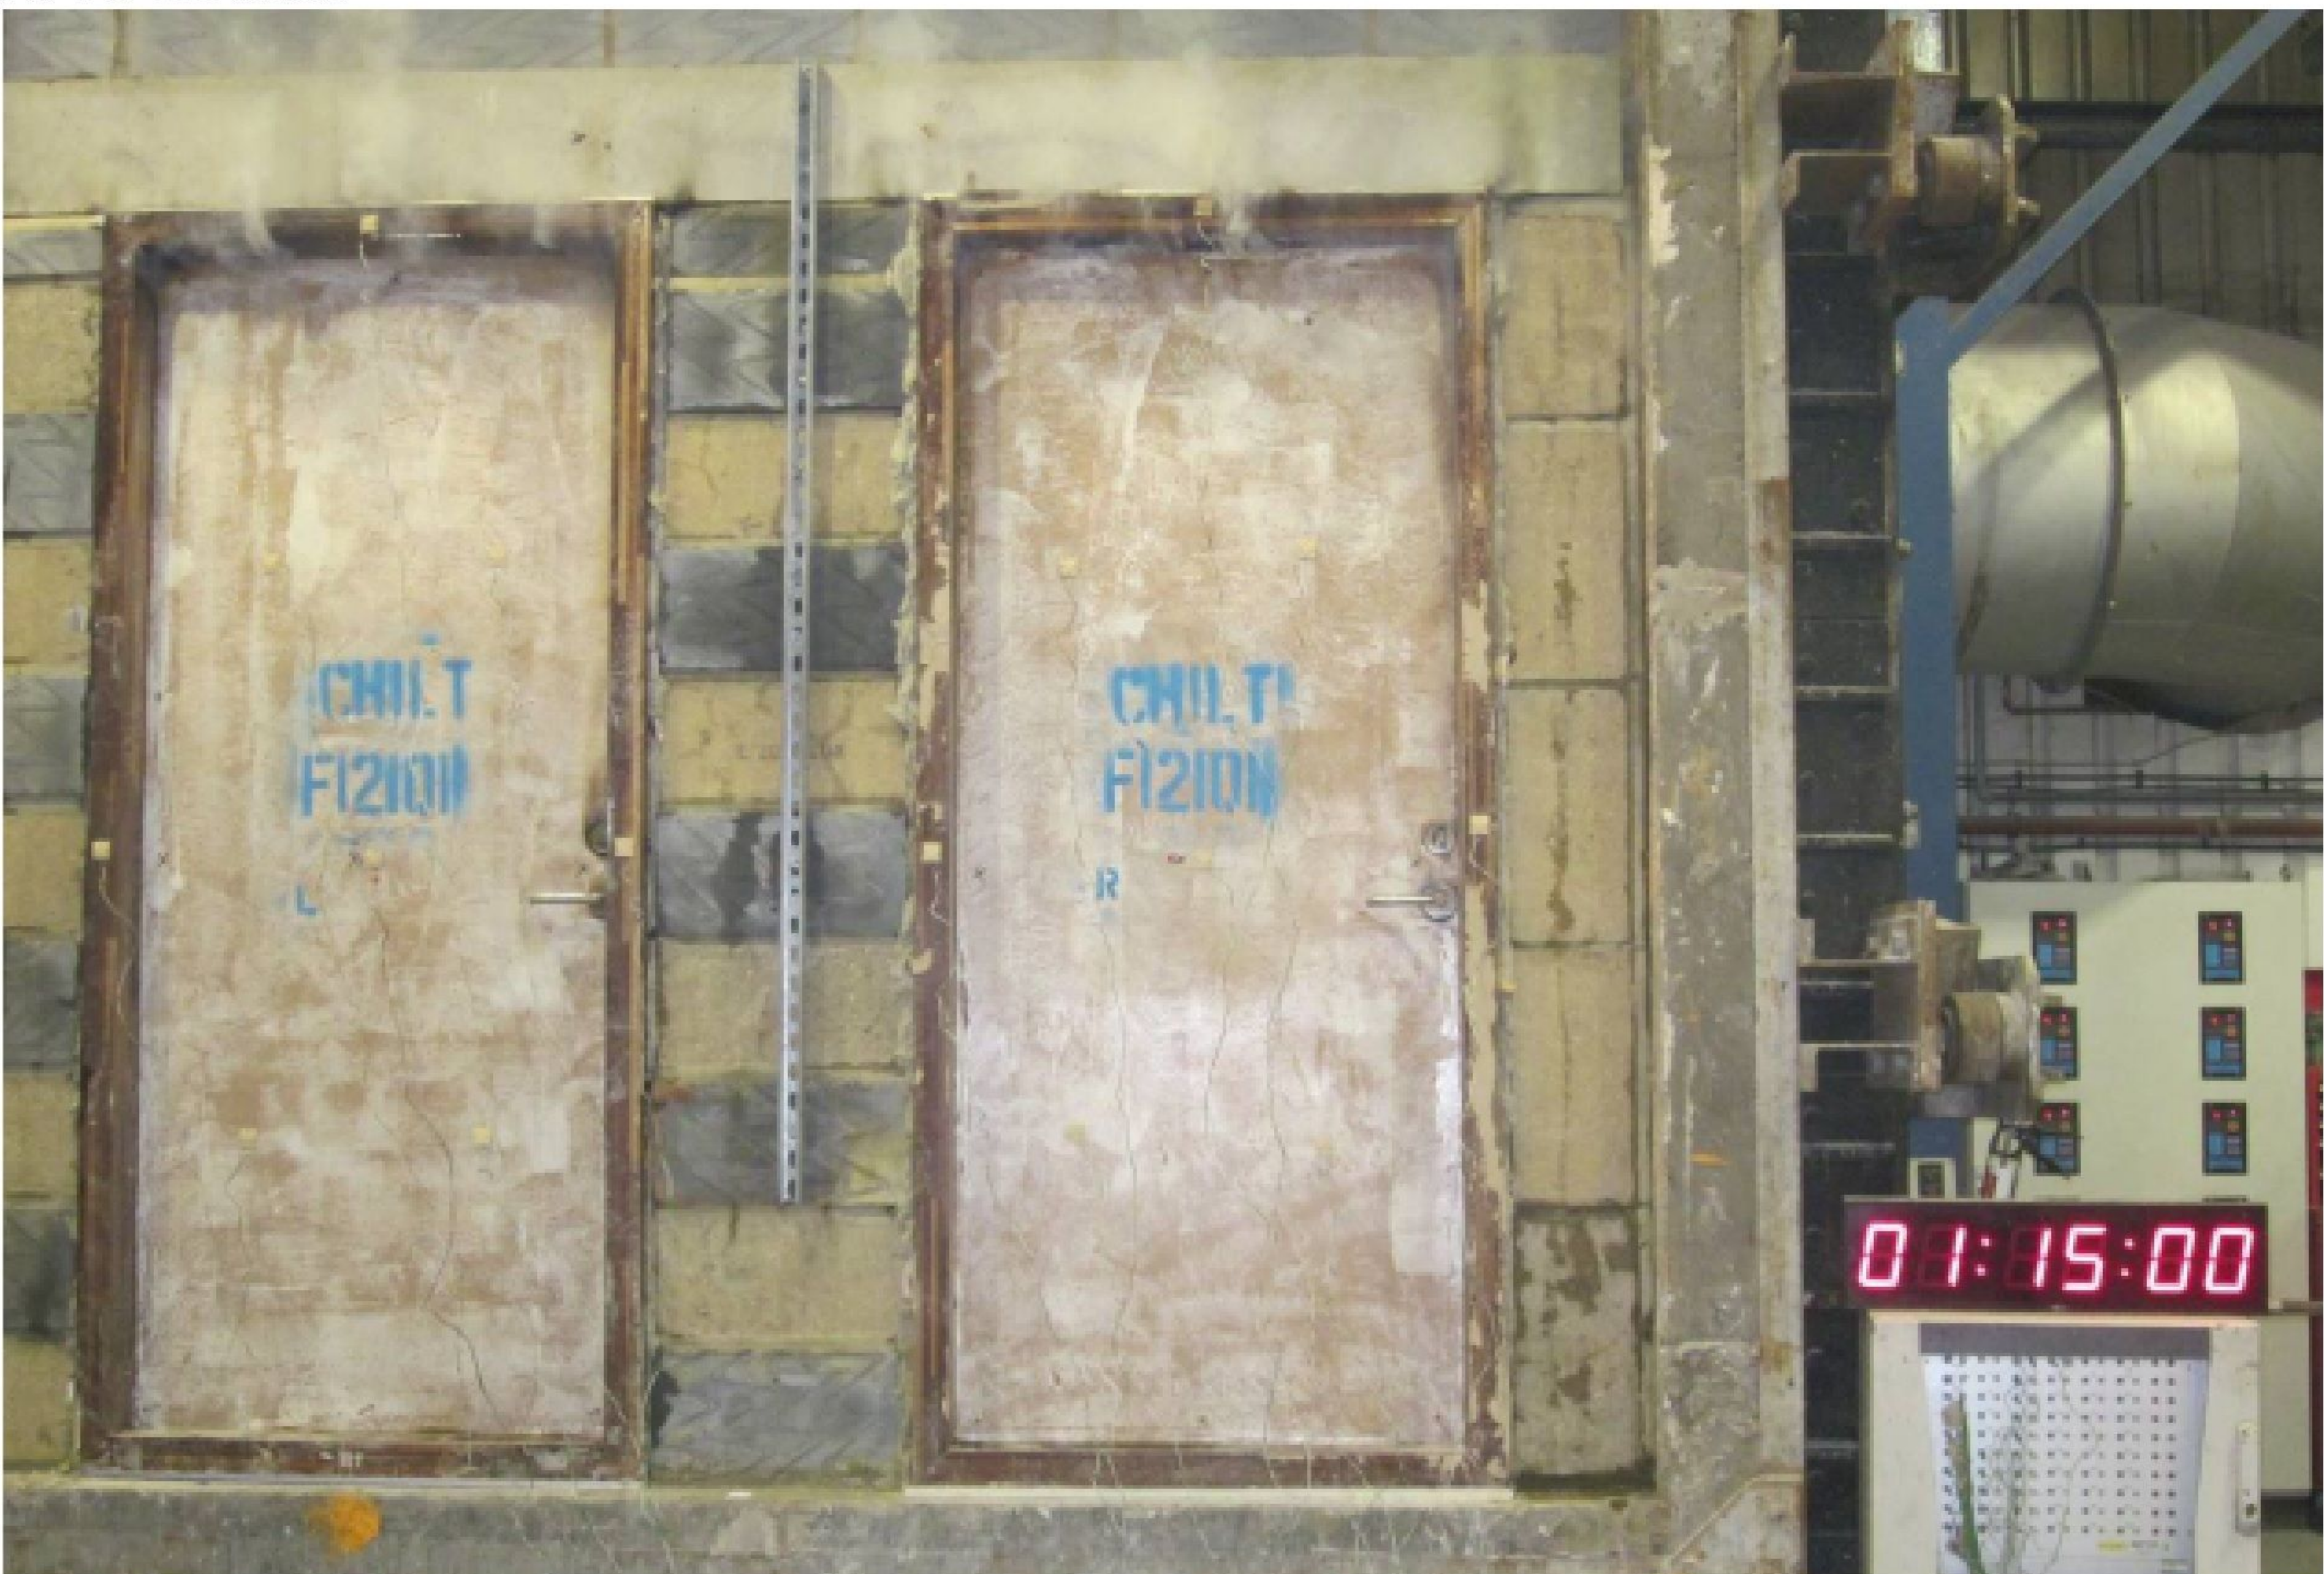
At 75 minutes

- 70.06 Doorset B, there is discolouration at the handle and keyhole positions.
- 74.00 Exposed face, doorset A the facing is falling away.
- 78.15 Doorset A, there is discolouration at the top hanging and top closing corner of the leaf. There is erosion at the threshold of the leaf.
