**Report: Chilt/RF12101**

**A fire resistance test performed two  
single leaf single acting doorsets**

**Test conducted in accordance with  
BS 476: Parts 20/22: 1987**

**Test date: 19th October 2012**

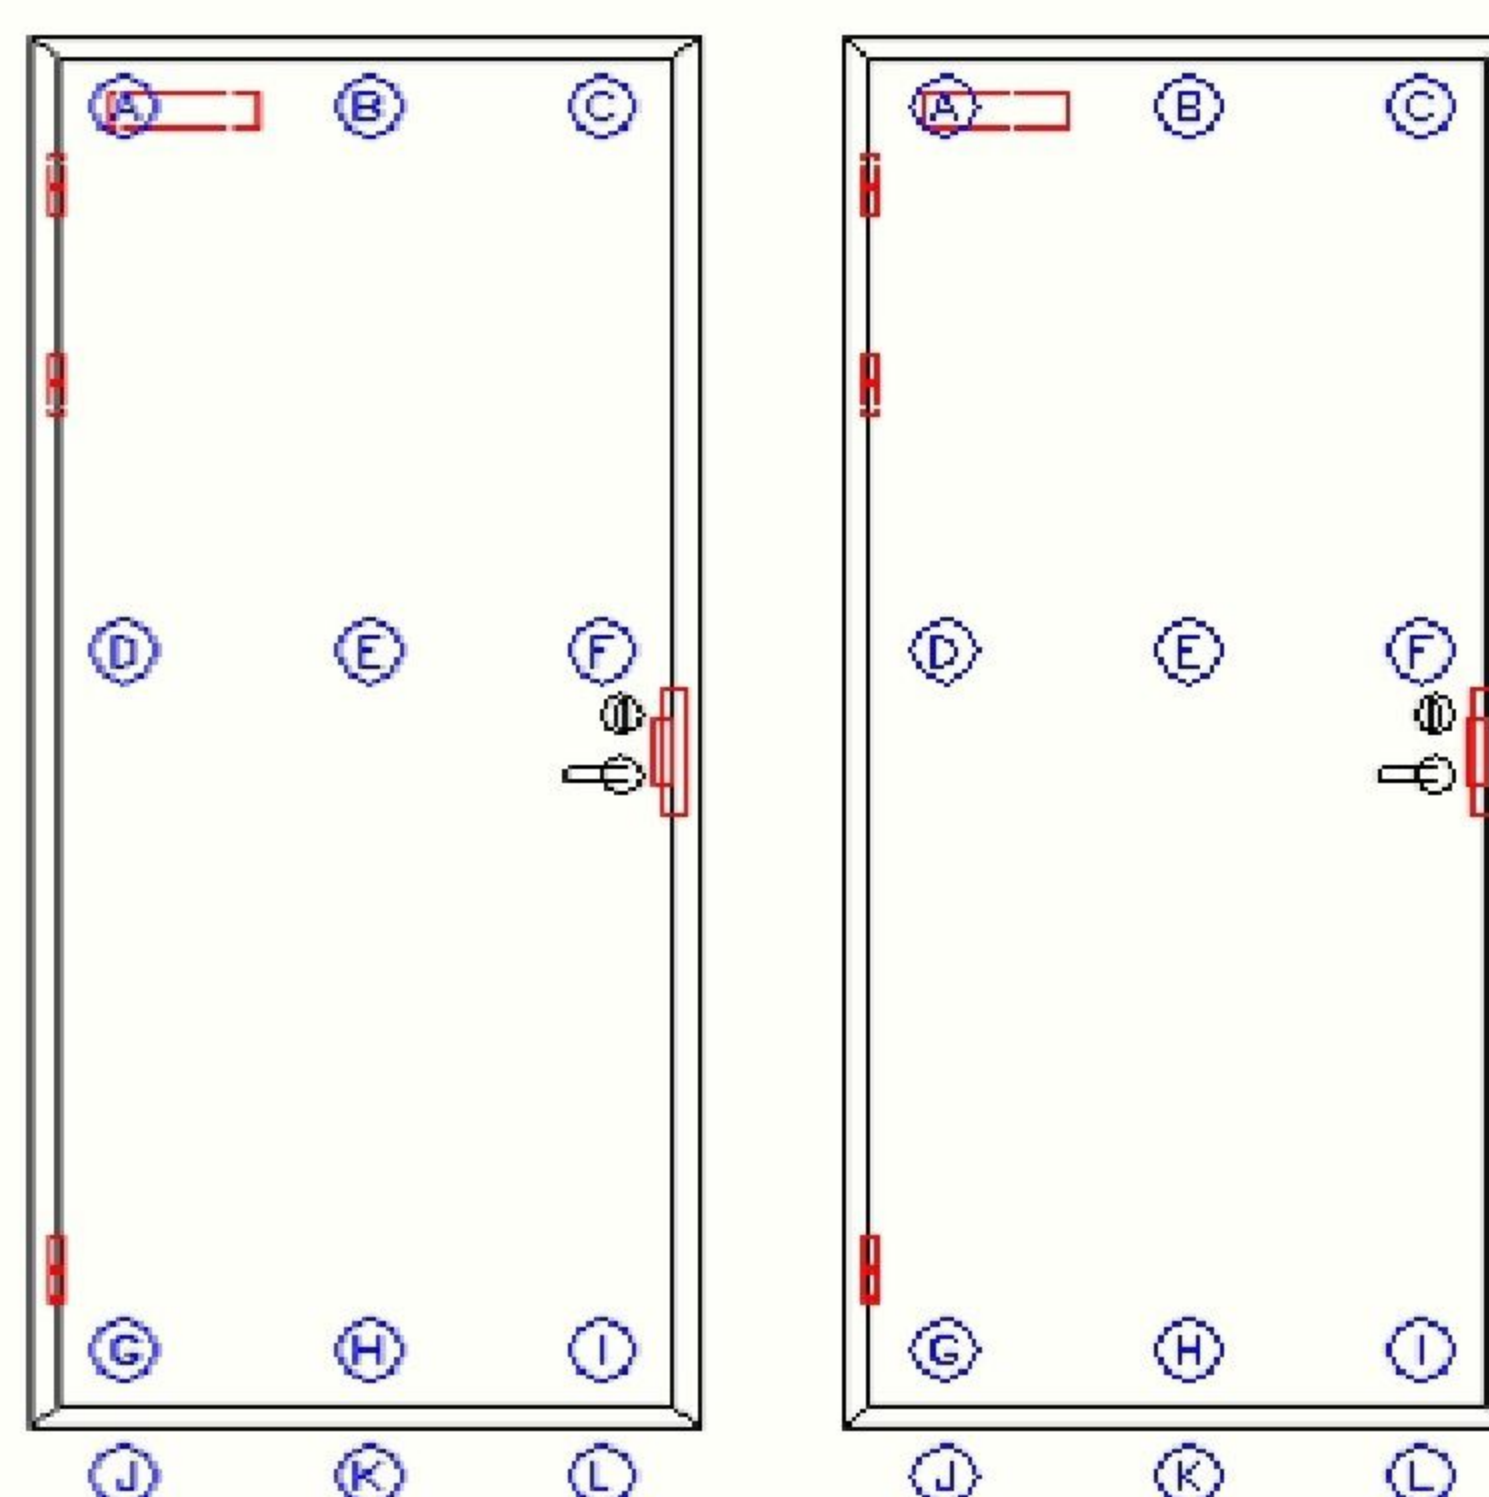
The following tables show the distortion of the doors in mm with an accuracy of  $\pm 1$ mm.

A positive measurement indicates distortion towards the furnace.

A negative measurement indicates distortion away from the furnace.

J, K and L give vertical movement of the door, a negative reading indicates that the door has dropped.
